Glacier Lake Dams

MANUAL FOR OPERATION AND MAINTENANCE

**State Water Projects Bureau
Water Resources Division
Department of Natural Resources and Conservation
48 North Last Chance Gulch
P.O. Box 201601
Helena, MT 59620-1601**

Initial Publication May 2001

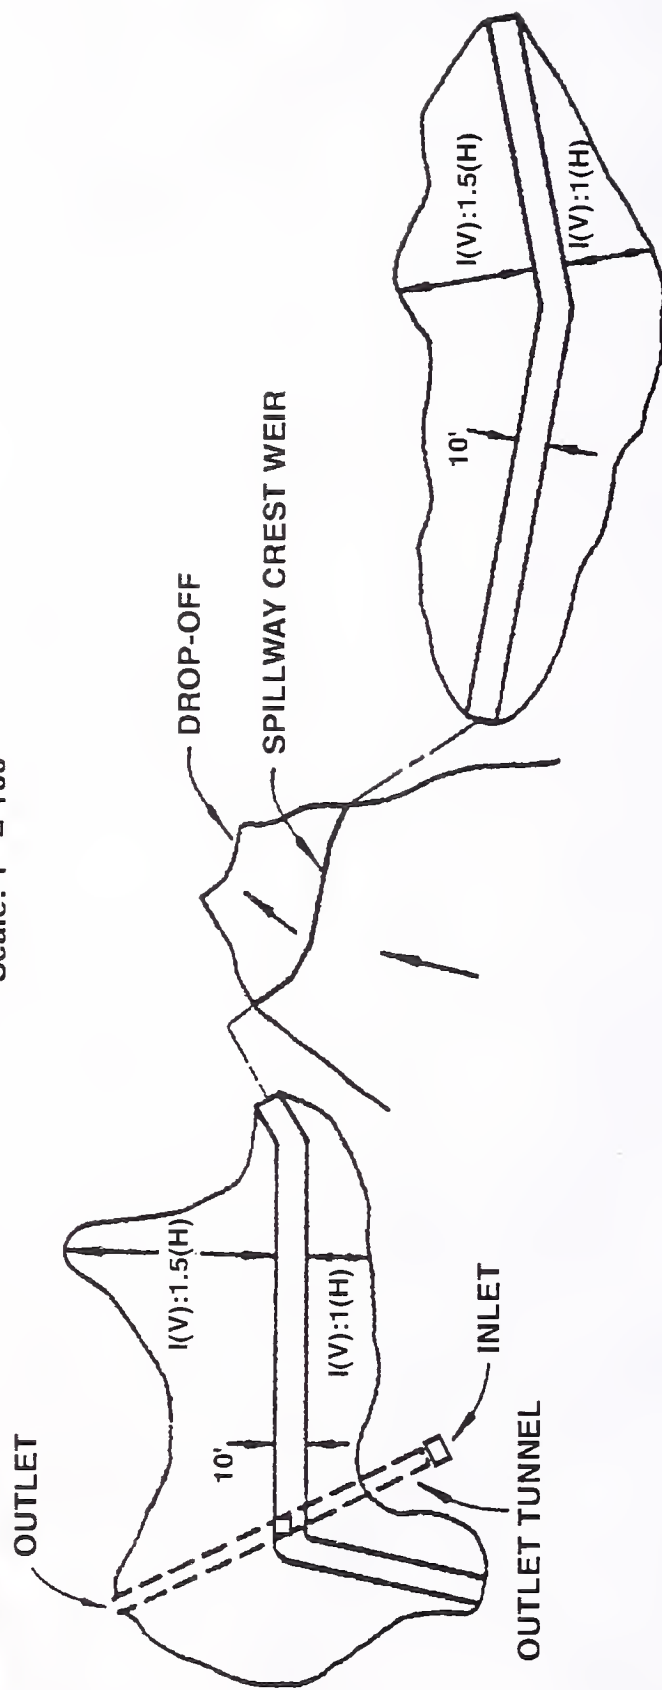
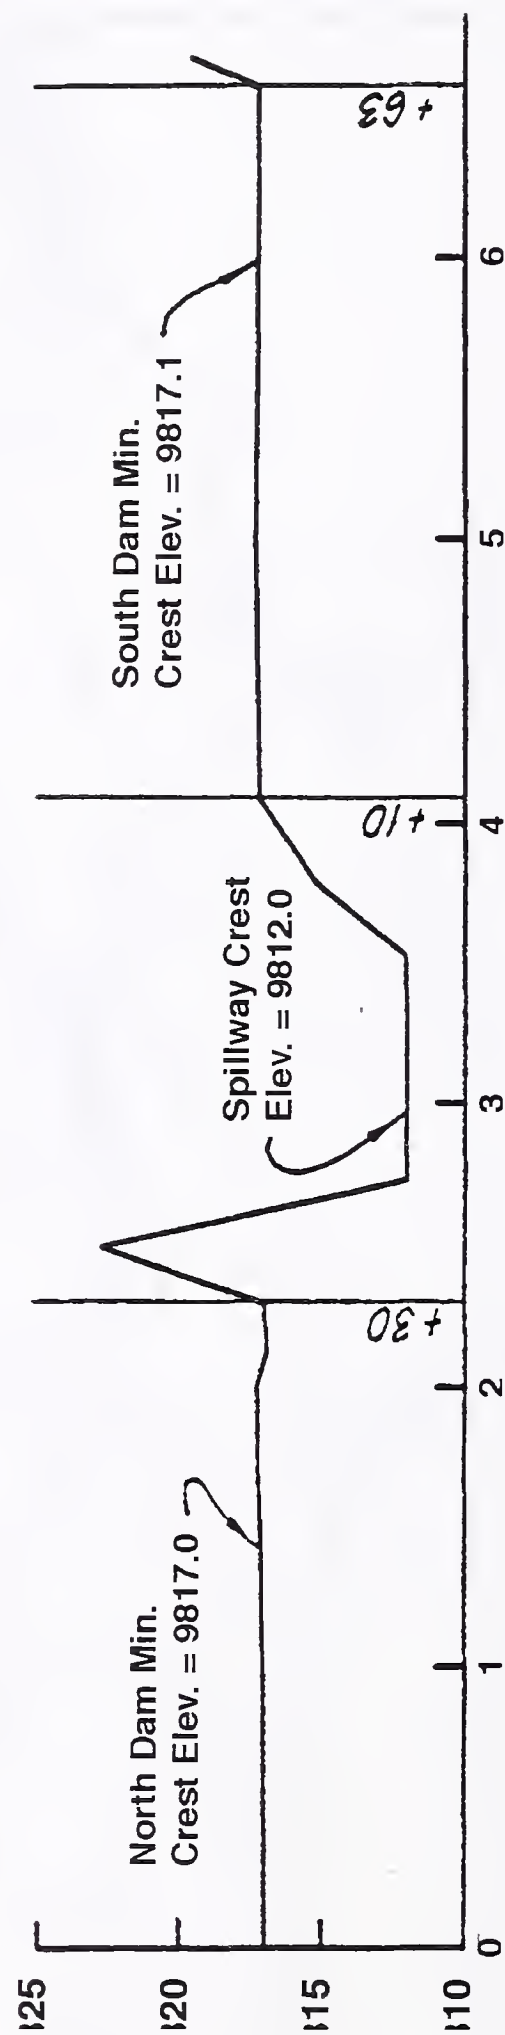
Figure 3. Glacier Lake Dam General Layout

Existing Project Plan

Scale: 1" = 100'

Existing Centerline Profile

Scale: 1" = 100'(H); 1" = 10'(V)

Both Glacier Lake dams are located on public land in the Custer National Forest administered by the U. S. Forest Service. The project is operated under a U.S. Forest Service special-use permit. Glacier Lake is located at the headwaters of Rock Creek in Carbon County, approximately 19 miles southwest of Red Lodge, Montana (see Figures 1 and 2). Figure 3 provides a general layout of the dam, spillway and outlet works. Figures 4 and 5 provide access route details.

Structural features include the gatehouse, spillway, and outlet works (Figure 3). The SWPB will inspect these structures annually as part of its inspection program. Items to be checked or noted include, but are not limited to:

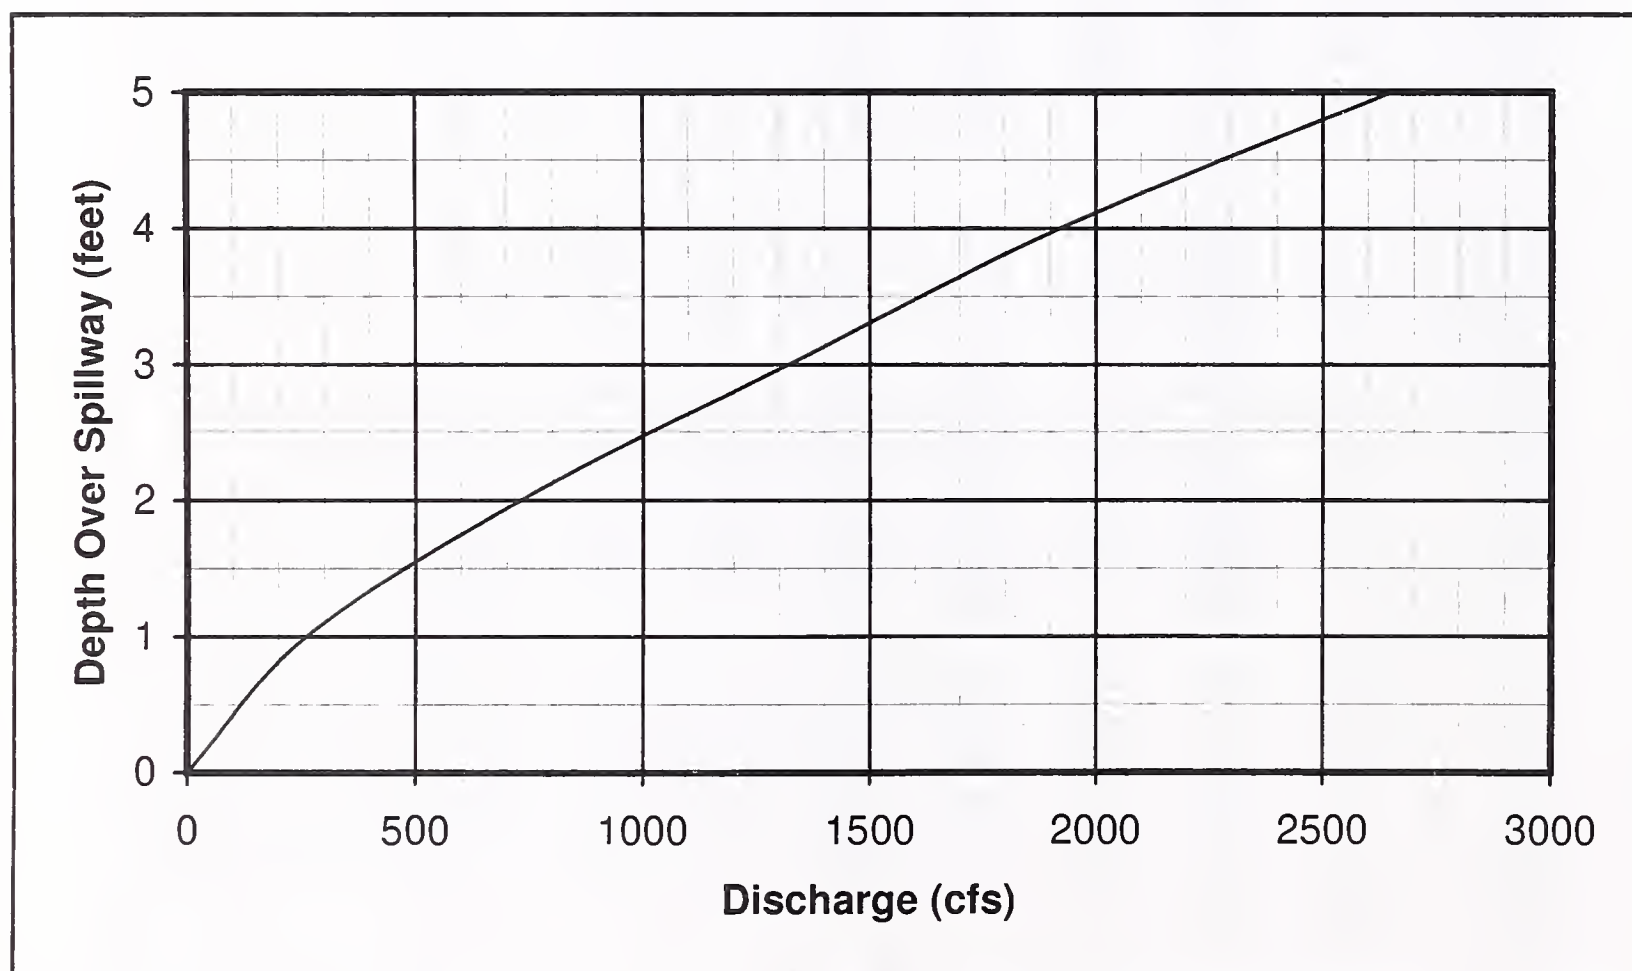
GLACIER LAKE RESERVOIR

Depth Over Crest (feet)	Elevation (feet)	Discharge (cfs)
0	9812	0
1	9813	260
2	9814	730
3	9815	1320
4	9816	1920
5	9817	2650

Note: Data from the Corps of Engineers Phase 1 Inspection Report (1981).

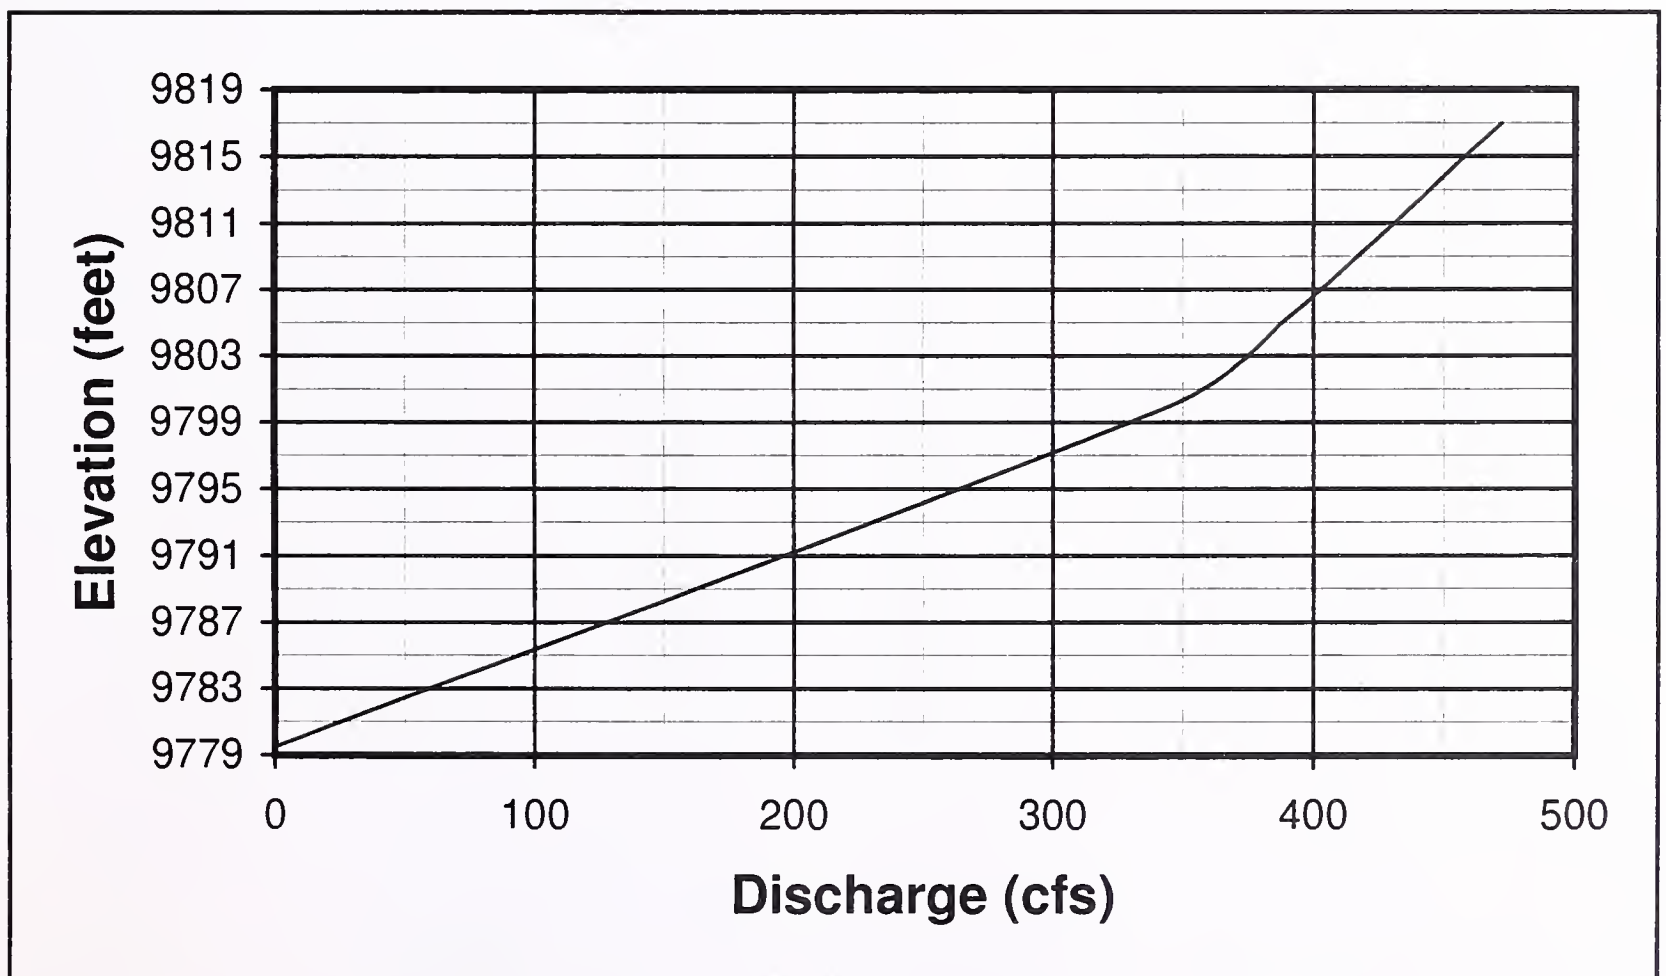
TABLE 4. OUTLET DISCHARGE
GLACIER LAKE RESERVOIR

Reservoir Elevation (feet)	Discharge (cfs)
9779.5	0
9800	345
9805	388
9810	424
9815	458
9817	472

Note: Discharge assumes gate is completely open.

Note: Data from the Corps of Engineers Phase 1 Inspection Report (1981).

The low level outlet, located in the left abutment of the North Dam, consists of a rock tunnel approximately 6.5 feet high and 5.5 feet wide. The discharge is controlled with a 48-inch by 48-inch vertical slide gate located in a single cell wet tower. The manual control mechanism is located in a wooden gate house on the dam crest. The maximum capacity of the outlet is 472 cubic feet per second (cfs). The outlet releases water into the Rock Creek drainage.

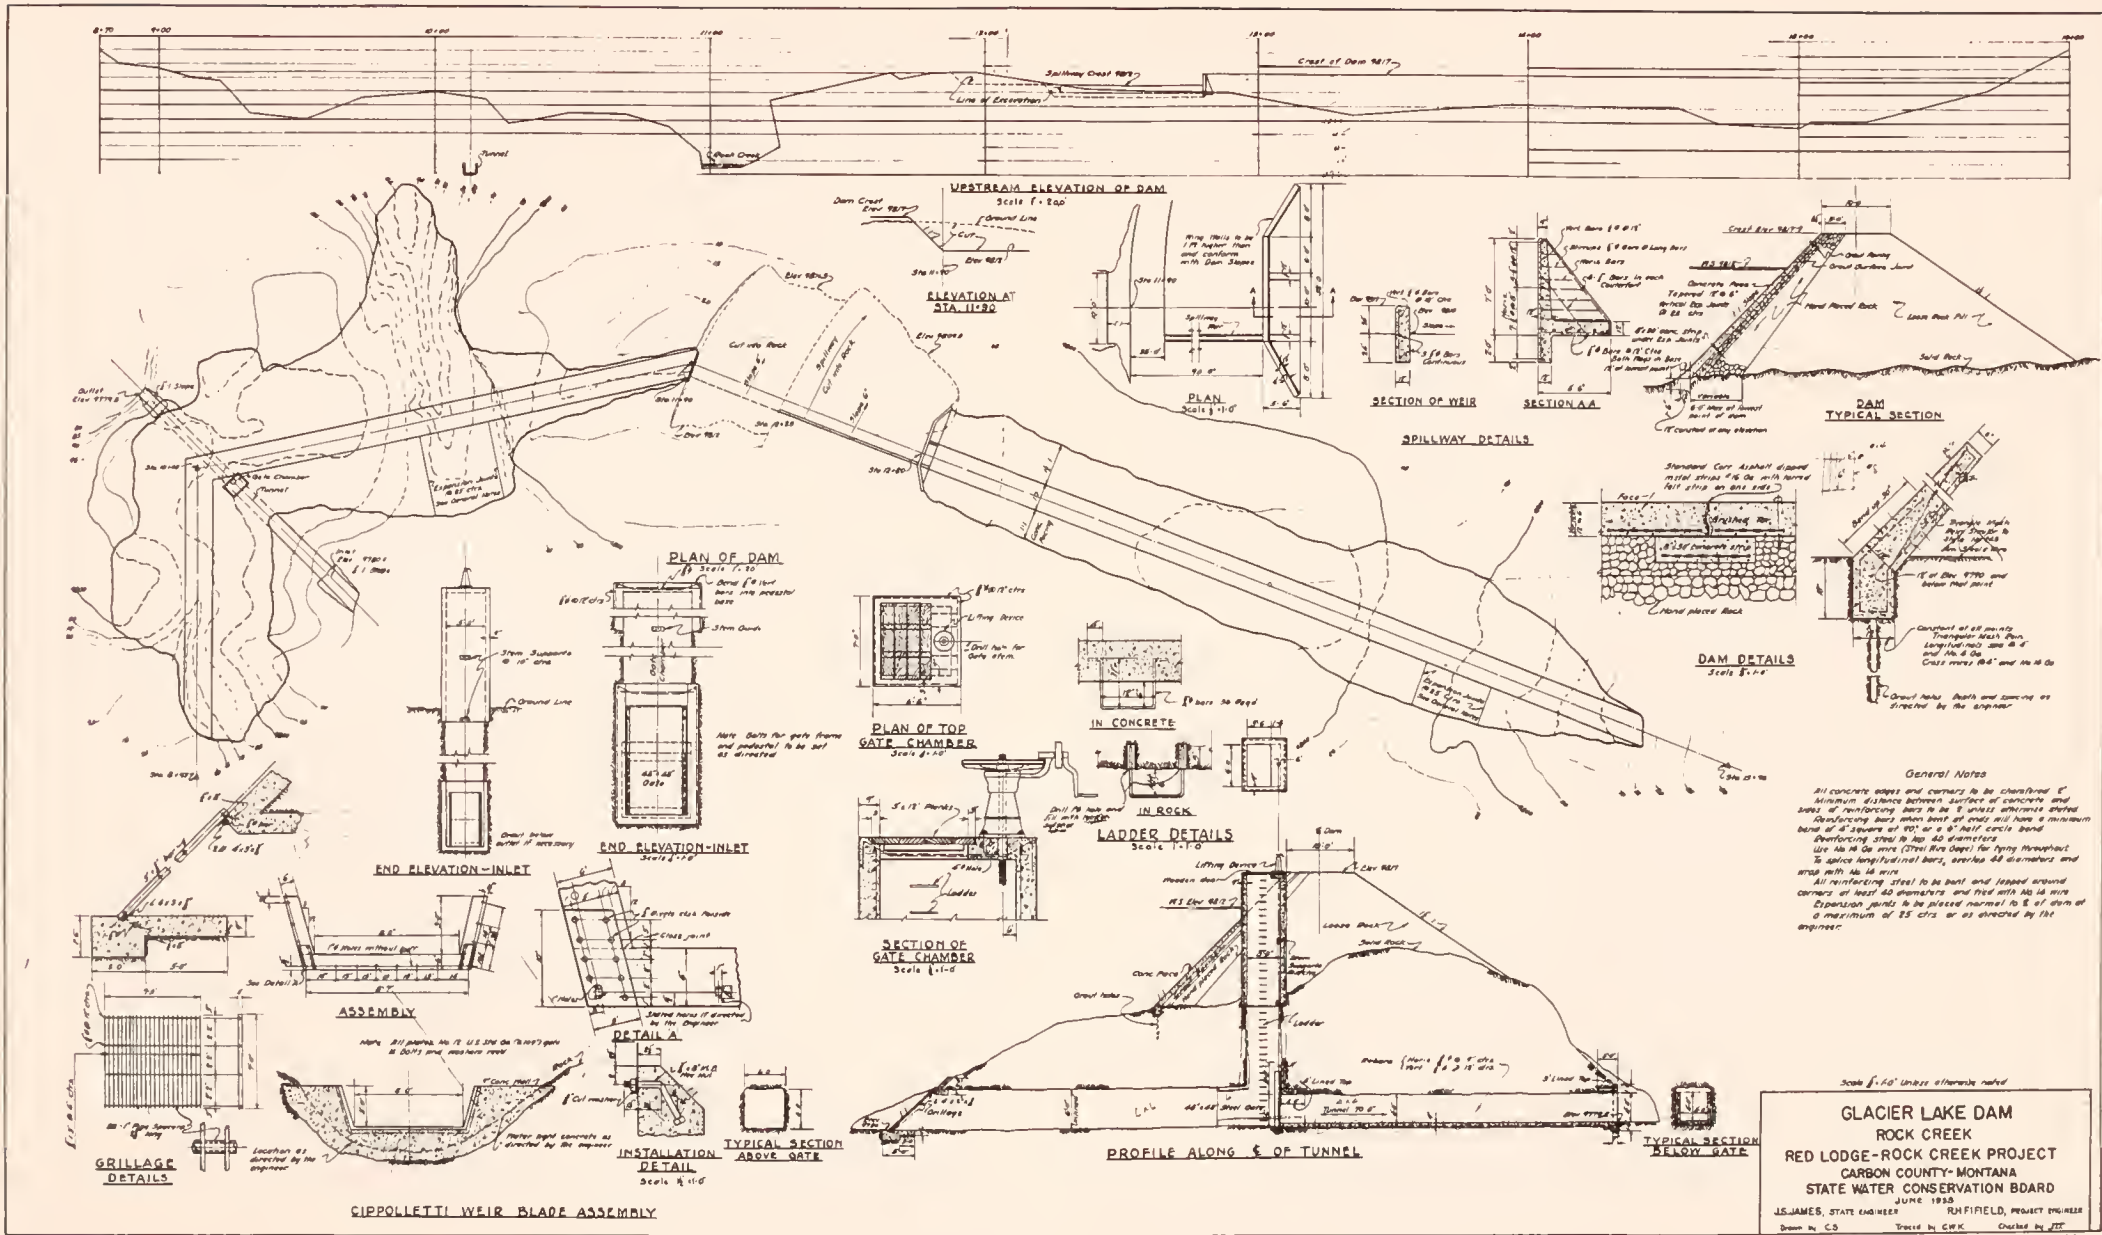
PROJECT DRAWINGS

(NOTE: These reduced project drawings are design drawings and not "As Builts". These drawing should be used for reference only. The SWPB has the full size project drawings.)
